Fracture and Failure Analysis of Wheel Bolt on Main Landing Gear CN235 220M Aircraft

The wheel bolt of the CN235 220M aircraft is a type of fastener crucial for maintaining air pressure within the tire. It was discovered that this component fractured during operation. This study aims to conduct forensic analysis on the mechanism and causes of material failure through micro and macro morphological observations, chemical composition tests, microstructural analysis, and hardness testing on the fractured bolt, including FEA analysis. The FEA analysis shows satisfactory results, confirming the accuracy of the premature fracture location. Micro-morphology results showed a crack tip in the initiation zone, which became a stress concentration point. Additionally, striations caused by cyclic loading were observed. EDS analysis revealed a high oxygen content in the initiation zone, indicating a corrosion-assisted crack. As cyclic loading continued, it gradually eroded the bolt's cross-sectional area until the material's fatigue led to final fracture. Recommendations can be taken such as controlling environmental factors using rust inhibitors, controlling humidity, implementing appropriate i

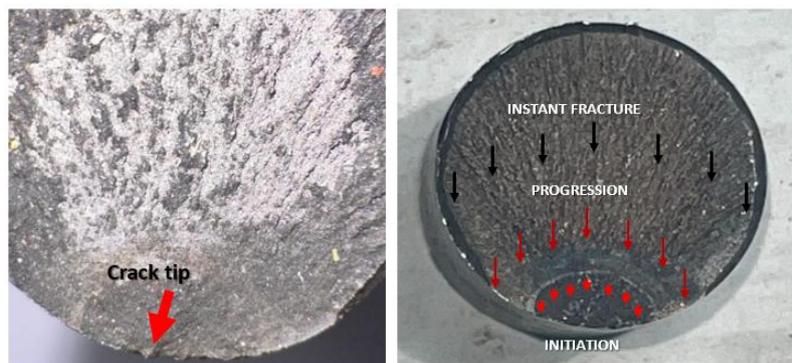
Visual inspection of the fracture surface of the failed bolt was conducted. Figure 1 shows a macrograph of the fractured bolt. Macroscopically, a crack tip is observed in the crack initiation zone. The crack then grew gradually until the effective cross-sectional area reached a critical point, resulting in an instantaneous final fracture. The fracture surface exhibited a flat and wavy profile, indicating that crack propagation occurred due to shear lips and a mixed-mode fracture. Additionally, the surface roughness changed from smooth to coarse in the direction of crack propagation, suggesting that the material had experienced cyclic loading and a transformation in the fracture mode [3].

Figure 1. Macrograph of fractured bolt

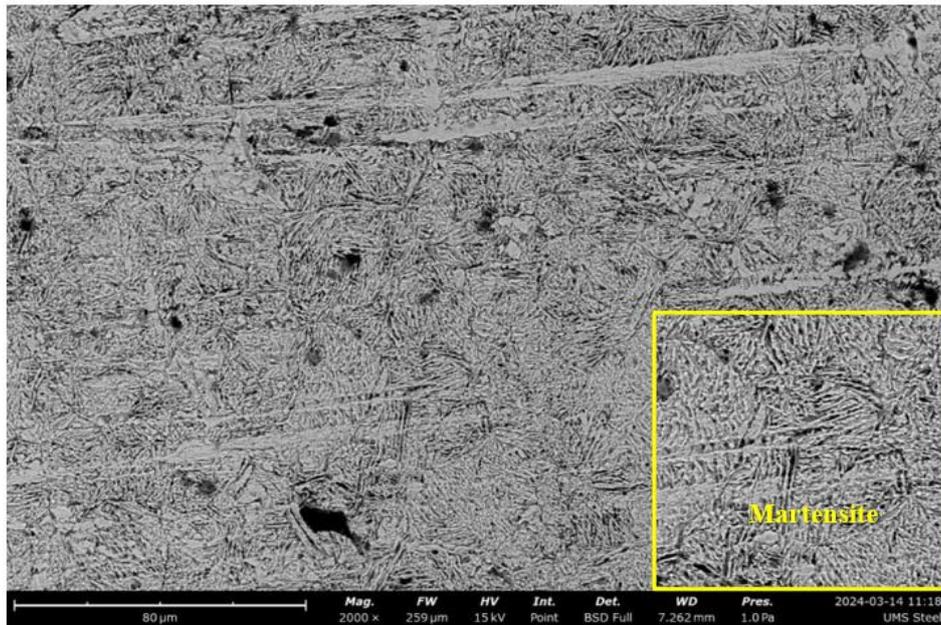
Figure 2 shows metallographic analysis of the CN235 wheel bolt observed with SEM at high magnification. SEM observations revealed a martensitic microstructure with carbides precipitating at the grain boundaries and within the grains. Martensite appeared as needle-like or plate-like structures with rough surfaces and high contrast. The carbides were fine particles evenly distributed throughout the matrix.

Based on spectrophotometric analysis, the carbon content was found to be 0.4%, classifying the material as hypoeutectoid steel. Martensite forms in hypoeutectoid steel subjected to quenching (rapid cooling) and is subsequently tempered, causing carbide precipitation within the martensite. This structure provides an optimal combination of hardness, strength, toughness, and wear resistance, making the material highly suitable for aviation applications. The homogeneity in carbide distribution also indicates good material quality and well-controlled manufacturing processes.

Figure 2. SEM image of bolt's microstructure

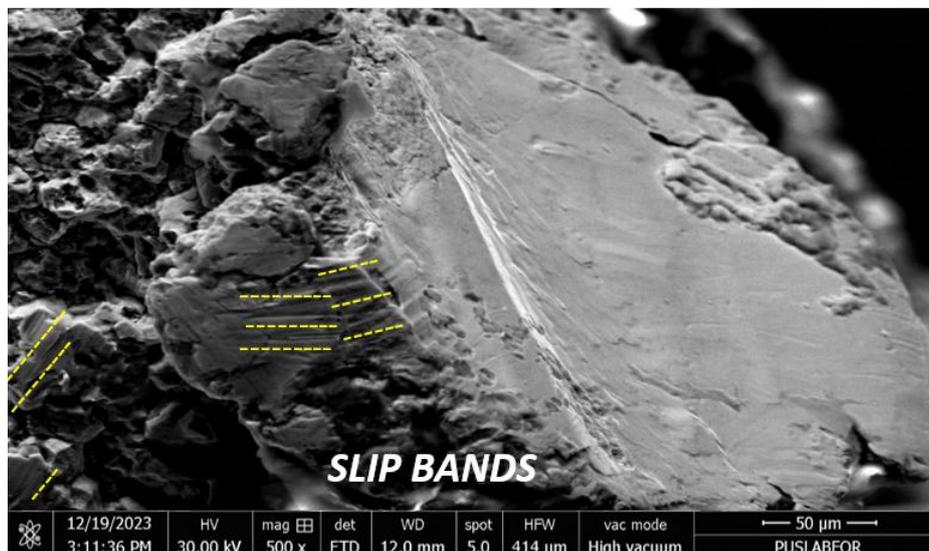
Figure 3. Slip bands appearance on the fracture surface

Figure 3 shows SEM observations that revealed slip bands and an initiation zone on the outer surface of the component. Cyclic slip forms at stress amplitudes below the yield limit. Slips tend to occur on the material surface due to less restriction on their movement. Slip occurs from localized irreversible deformation caused by concentrated cyclic loading. The newly exposed material surface becomes covered by an oxide layer, leading to strain hardening. Consequently, subsequent slips accumulate and form microcracks that can continue to grow under further cyclic loading.

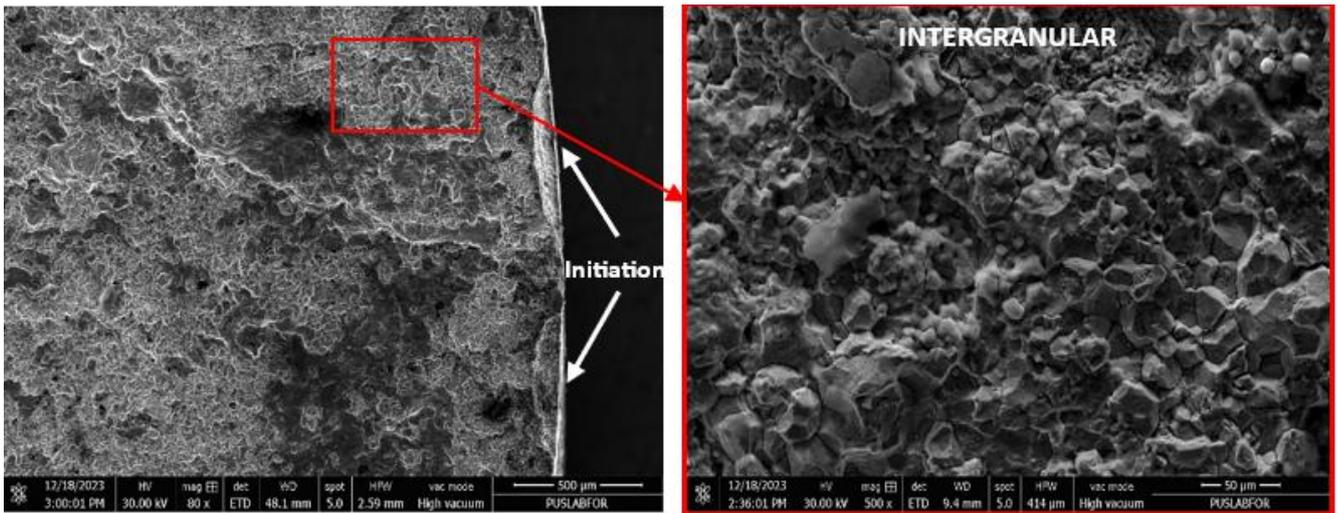
Figure 4. Initiation zone at the fractured surface

In the initiation zone, cracks were observed propagating through grain boundaries. Figure 4 indicates grain boundary weakness due to corrosion, which accelerates crack growth. At higher magnification (200x), striations were observed, implying single-cycle stress on the fatigue crack. Striation patterns (Figure 5) are perpendicular to the direction of crack propagation. The variation in striation pitch indicates non-uniform loading cycles.

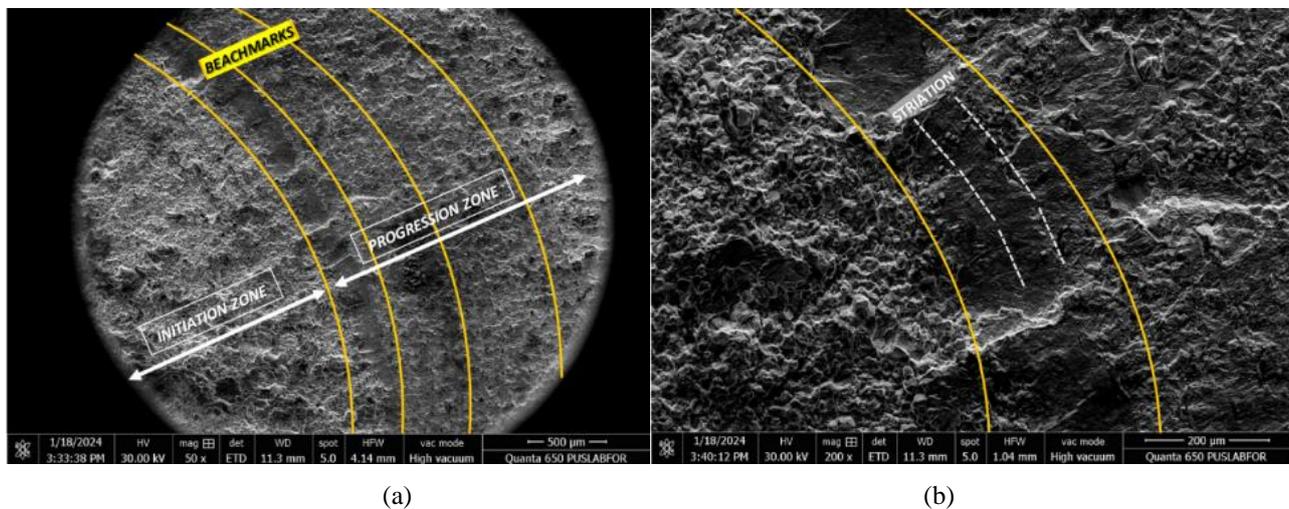
Figure 5. SEM images of bolt's (a) fractured surface; and (b) higher magnification showing striation step

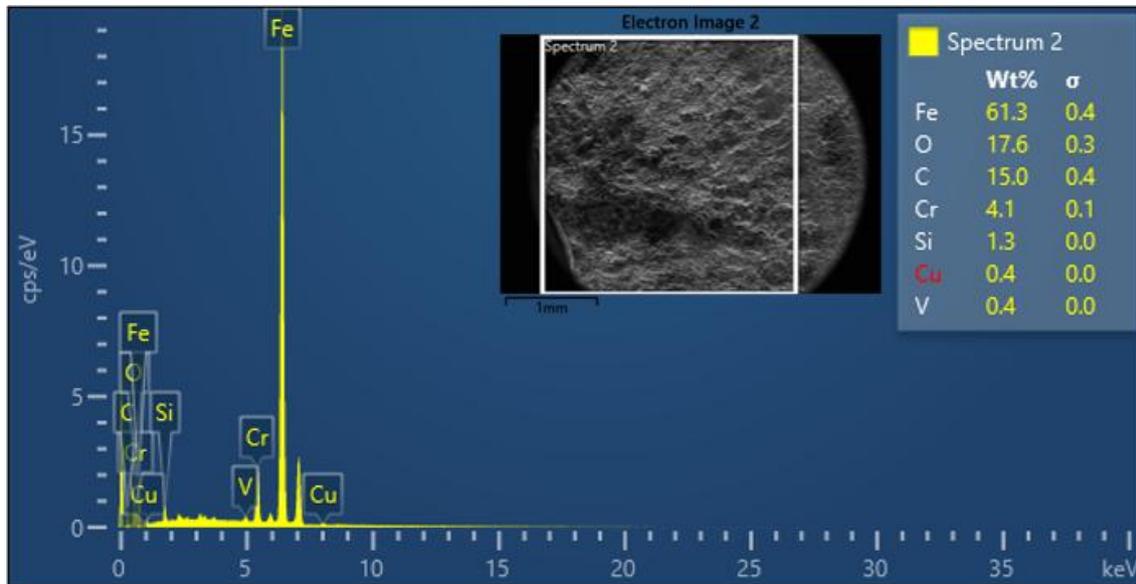
The initiation and propagation zones were analyzed using EDS. Figure 6 shows a higher oxygen content (17.6%) in the initiation zone. This supports the hypothesis that corrosion played a significant role in the failure mechanism and concludes that the failure occurred due to corrosion-assisted fatigue cracking. Corrosion fatigue can occur under cyclic

loading in a corrosive environment because slip bands facilitate anodic dissolution, which then grows into a crack initiation zone. The fatigue behavior of a material can drastically change in the presence of oxygen and moisture in the air. Similar findings have been consistent with others, showing that the combination of cyclic loads and a corrosive environment accelerates fatigue [14-16]. Table 2 indicates the micro Vickers hardness test results, which showed an increase in hardness near the fracture area, no longer complying with the standard. These results validate the occurrence of cyclic hardening due to cyclic loading in the stress concentration area.

Figure 6. EDS results of the fractured surface

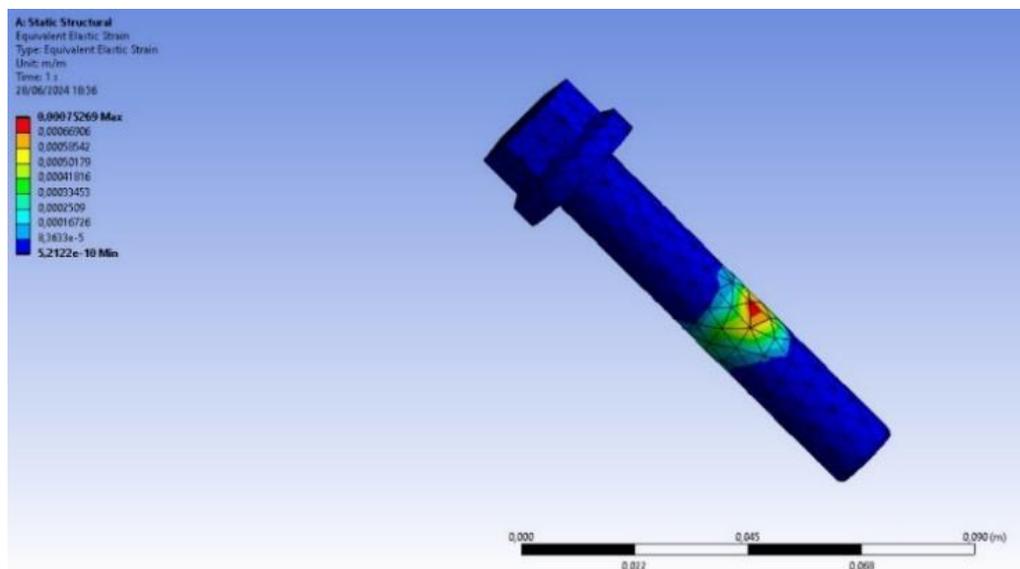
Figure 7 shows finite element analysis of the wheel bolt. The load applied to the bolt accommodates the overall weight, which is uniformly distributed on the aircraft's wheels, and tolerates the spike load that occurs during the landing process. The maximum shear stress and equivalent (Von-Mises) stress analysis results with static loading showed values of 50.9 MPa and 93.2 MPa, respectively, with a maximum elastic strain of 0.0075 concentrated at the fatigue failure initiation zone. Ideally, the maximum stress would undergo infinite cycles based on the available SN curve of the material. Thus, premature failure is discussed. This validates that the critical location has the highest potential to become a fatigue failure initiation zone. Additionally, the results show that the bolt design concentrates stress in the shank area, making it stronger than the threads.

Figure 7. Von-Mises stress of studied bolt using finite element analysis

The type of failure observed is fatigue failure with fracture propagation. Recommendations to prevent similar failures include reducing loading cycles and controlling environmental factors, such as using rust inhibitors, controlling humidity, or implementing appropriate inspection and maintenance strategies. Taking action to improve the most effective pilot driving behavior such as smooth and consistent throttle application ensures proper acceleration, inadequate rudder input or overcorrection can lead to asymmetric thrust or aerodynamic drag, proper flare technique results in a smooth landing, while immediate deployment of reverse thrust and brakes ensures rapid deceleration without undue stress on the airframe, and poor control during landing can lead to a hard landing and tailstrike. Additionally, re-evaluating bolt design (Figure 7) and material properties may help enhance performance and reduce failure risk.
