NUMERICAL ANALYSIS OF POST RAINFALL SLOPE STABILITY WITH REINFORCEMENT CASE STUDY IN PURWOSARI KULON PROGO

Abstract

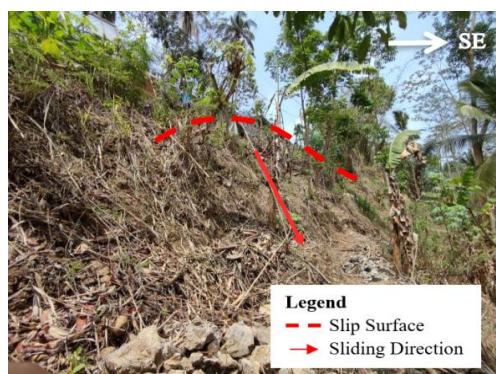
Figure 1a. Failure Pattern

The study area, located in Purwosari Village, Girimulyo District, experienced a rotational landslide (Figure 1a) in May 2023 at approximately 21:00 local time following several days of continuous rainfall. Field observations revealed tension cracks of approximately 4 cm on the road surface and the occurrence of mass movement along the slope, which disrupted local traffic (Figure 1b). Laboratory testing results (Table 1) classified the soil as ML (silt with low plasticity) according to the Unified Soil Classification System (USCS) based on the criteria of the U.S. Army Corps of Engineers (USACE, 1992), as illustrated in Figure 2. The soil has a cohesion (c) of 7.55 kPa and an internal friction angle (ϕ) of 32° , indicating relatively low shear strength. These parameters were used as input data for numerical simulations.

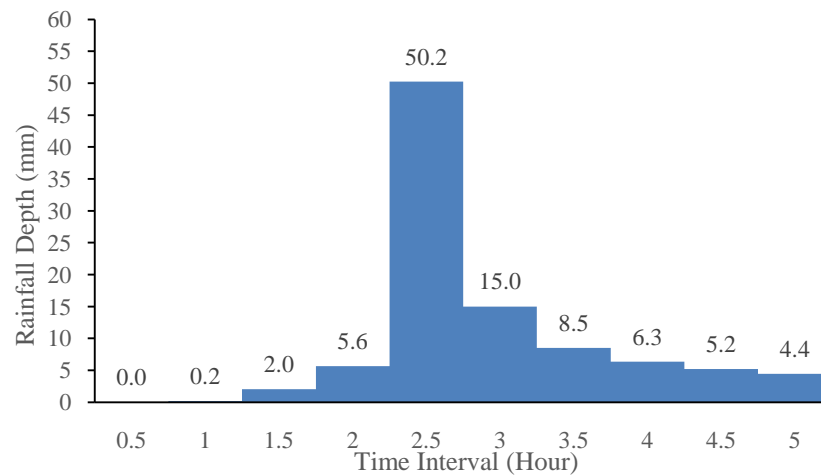
Figure 4. Rain Infiltration

infiltration depth of 97.6 mm during a 5-hour storm event (Figure 4).

as a total waterhead with constant values according to the respective elevations, representing a stable groundwater level. Rainfall infiltration was applied as a water flux boundary along the slope surface, with a total infiltration depth of 97.6 mm over a 5-hour storm event, as calculated using the SCS-CN method (Figure 4).

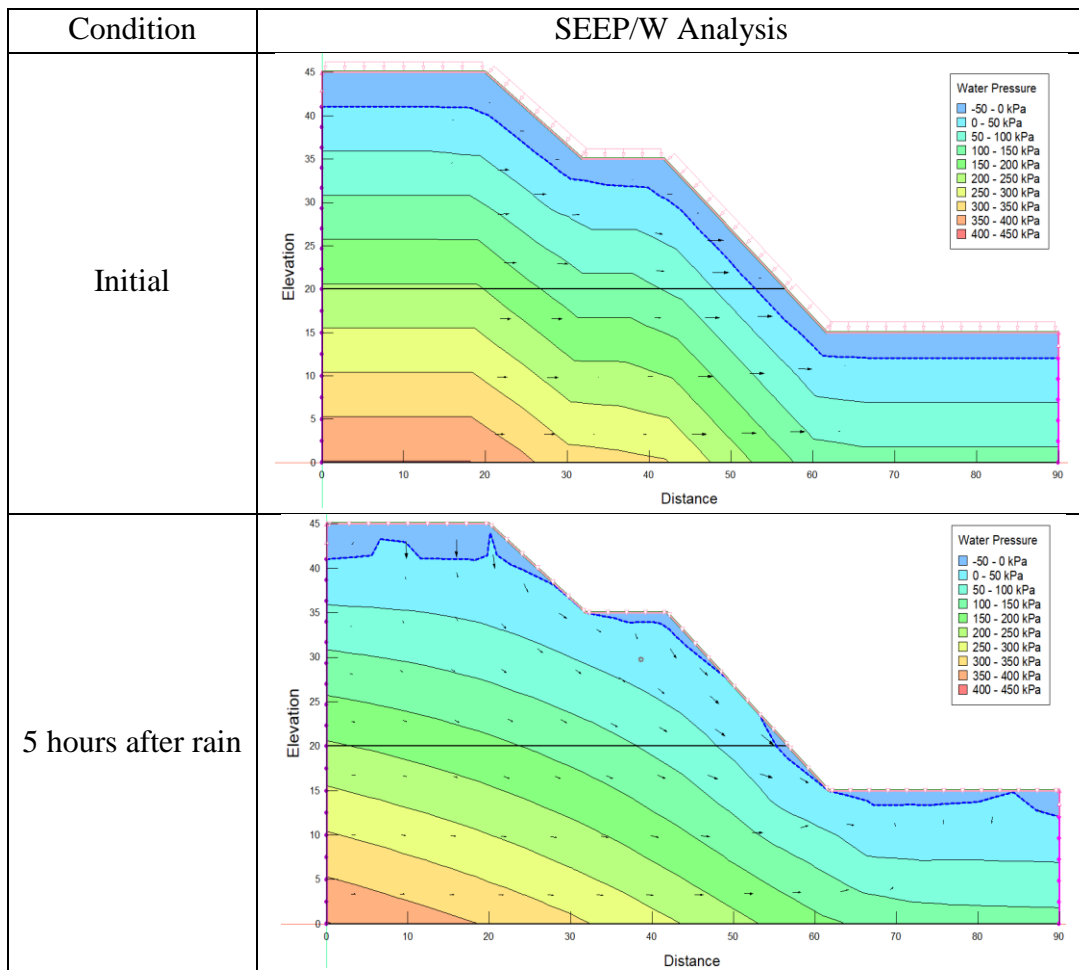
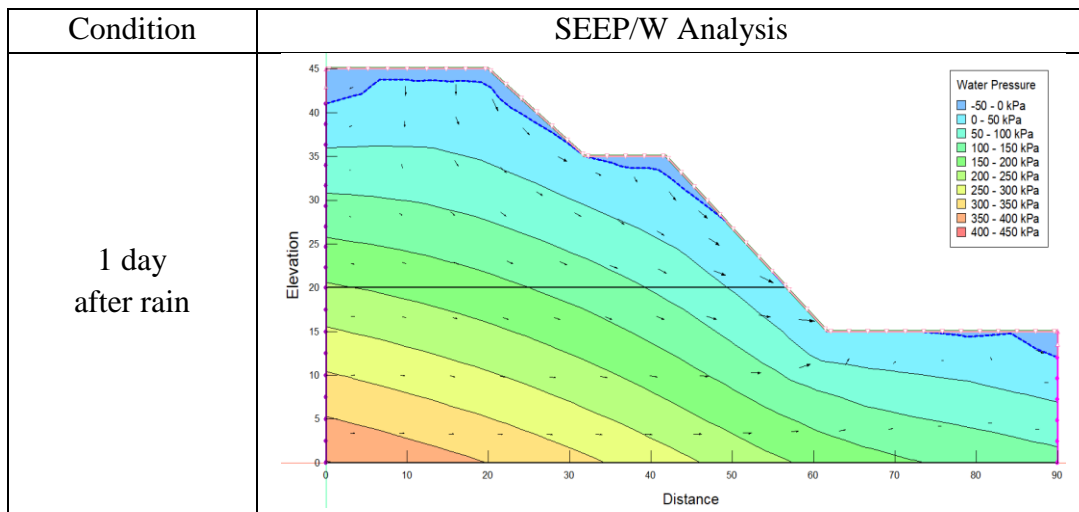
Table 5. Results of Existing Slope Analysis with SEEP/W

This flux condition simulates the downward entry of rainwater into the soil, which increases pore water pressure and raises the groundwater. The SEEP/W analysis results, presented in Table 5, show clear temporal variations in pore water pressure and groundwater movement. These variations occur because rainfall infiltration gradually fills the soil pores with water, leading to increased pore water pressure and a rising groundwater table. As the infiltration continues, the slope becomes progressively saturated, and the magnitude of these changes increases with rainfall duration (Wang et al. 2024a).
